TECHNICAL MEMORANDUM

To:	Mary Beth Marks	From:	Aaron Orechwa P.E.
Company:	USDA Forest Service	Date:	August 24, 2015
	10 East Babcock Ave	Project	
Address:	Bozeman, MT 59715	No.:	114-560846A
Re:	Bluff F, Bluff G, and Bluff I 2015 Sampling Final Memo

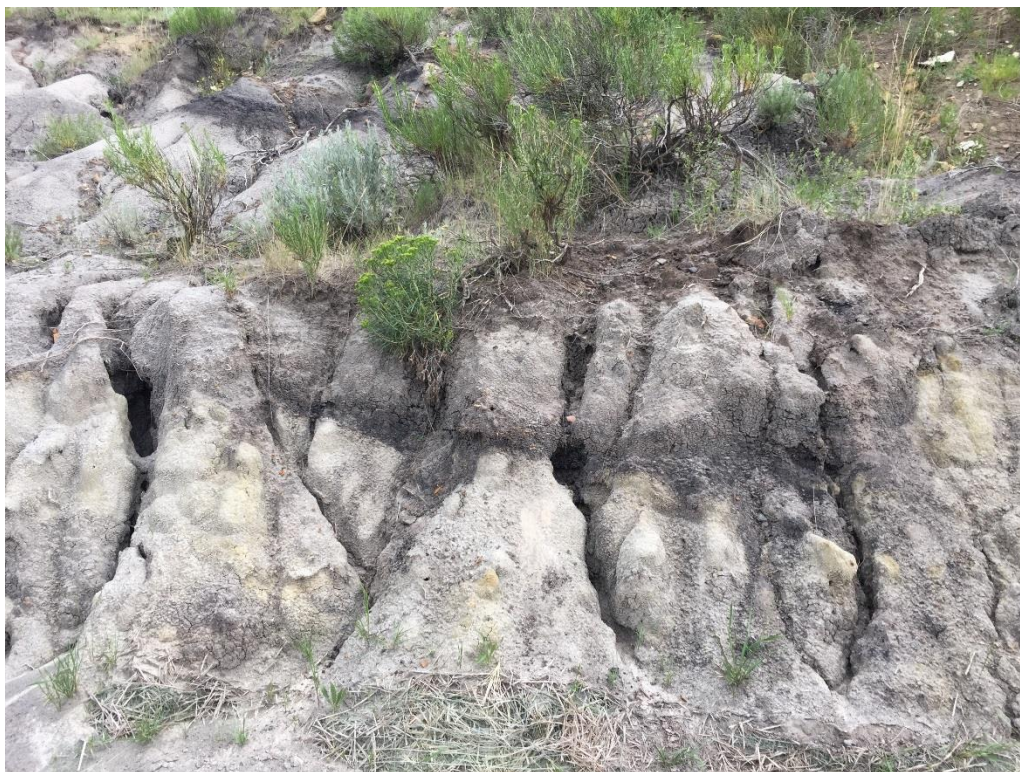
Exposed Lignite Lense south of point IQ-13

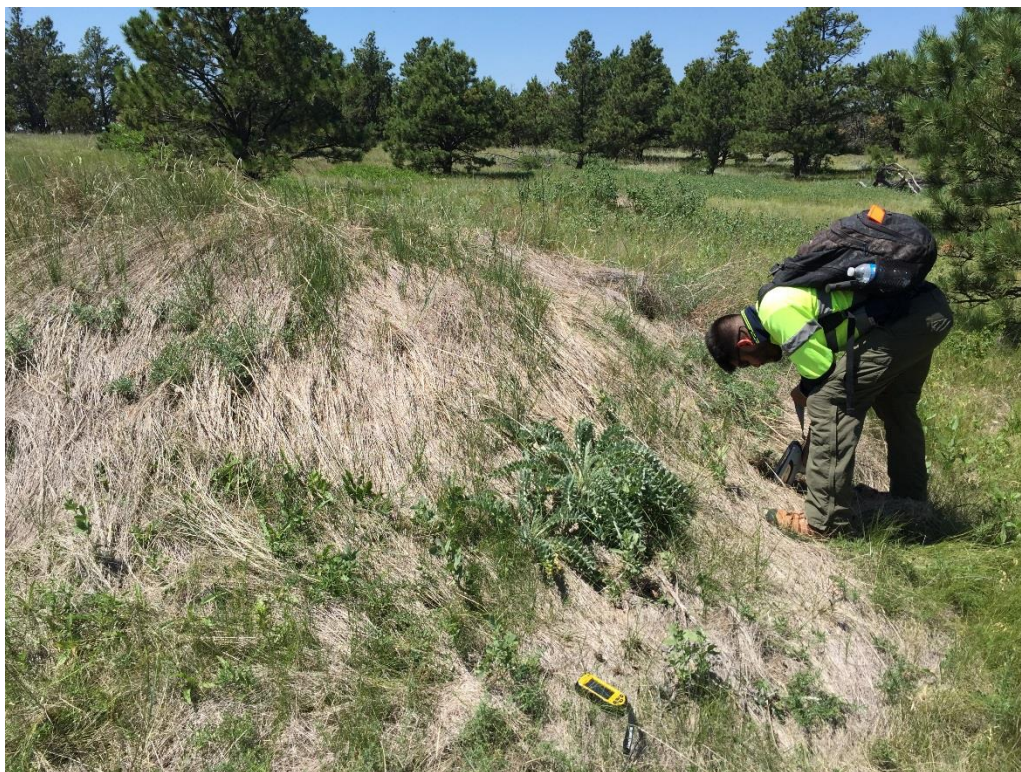
Pile at Bluff F
